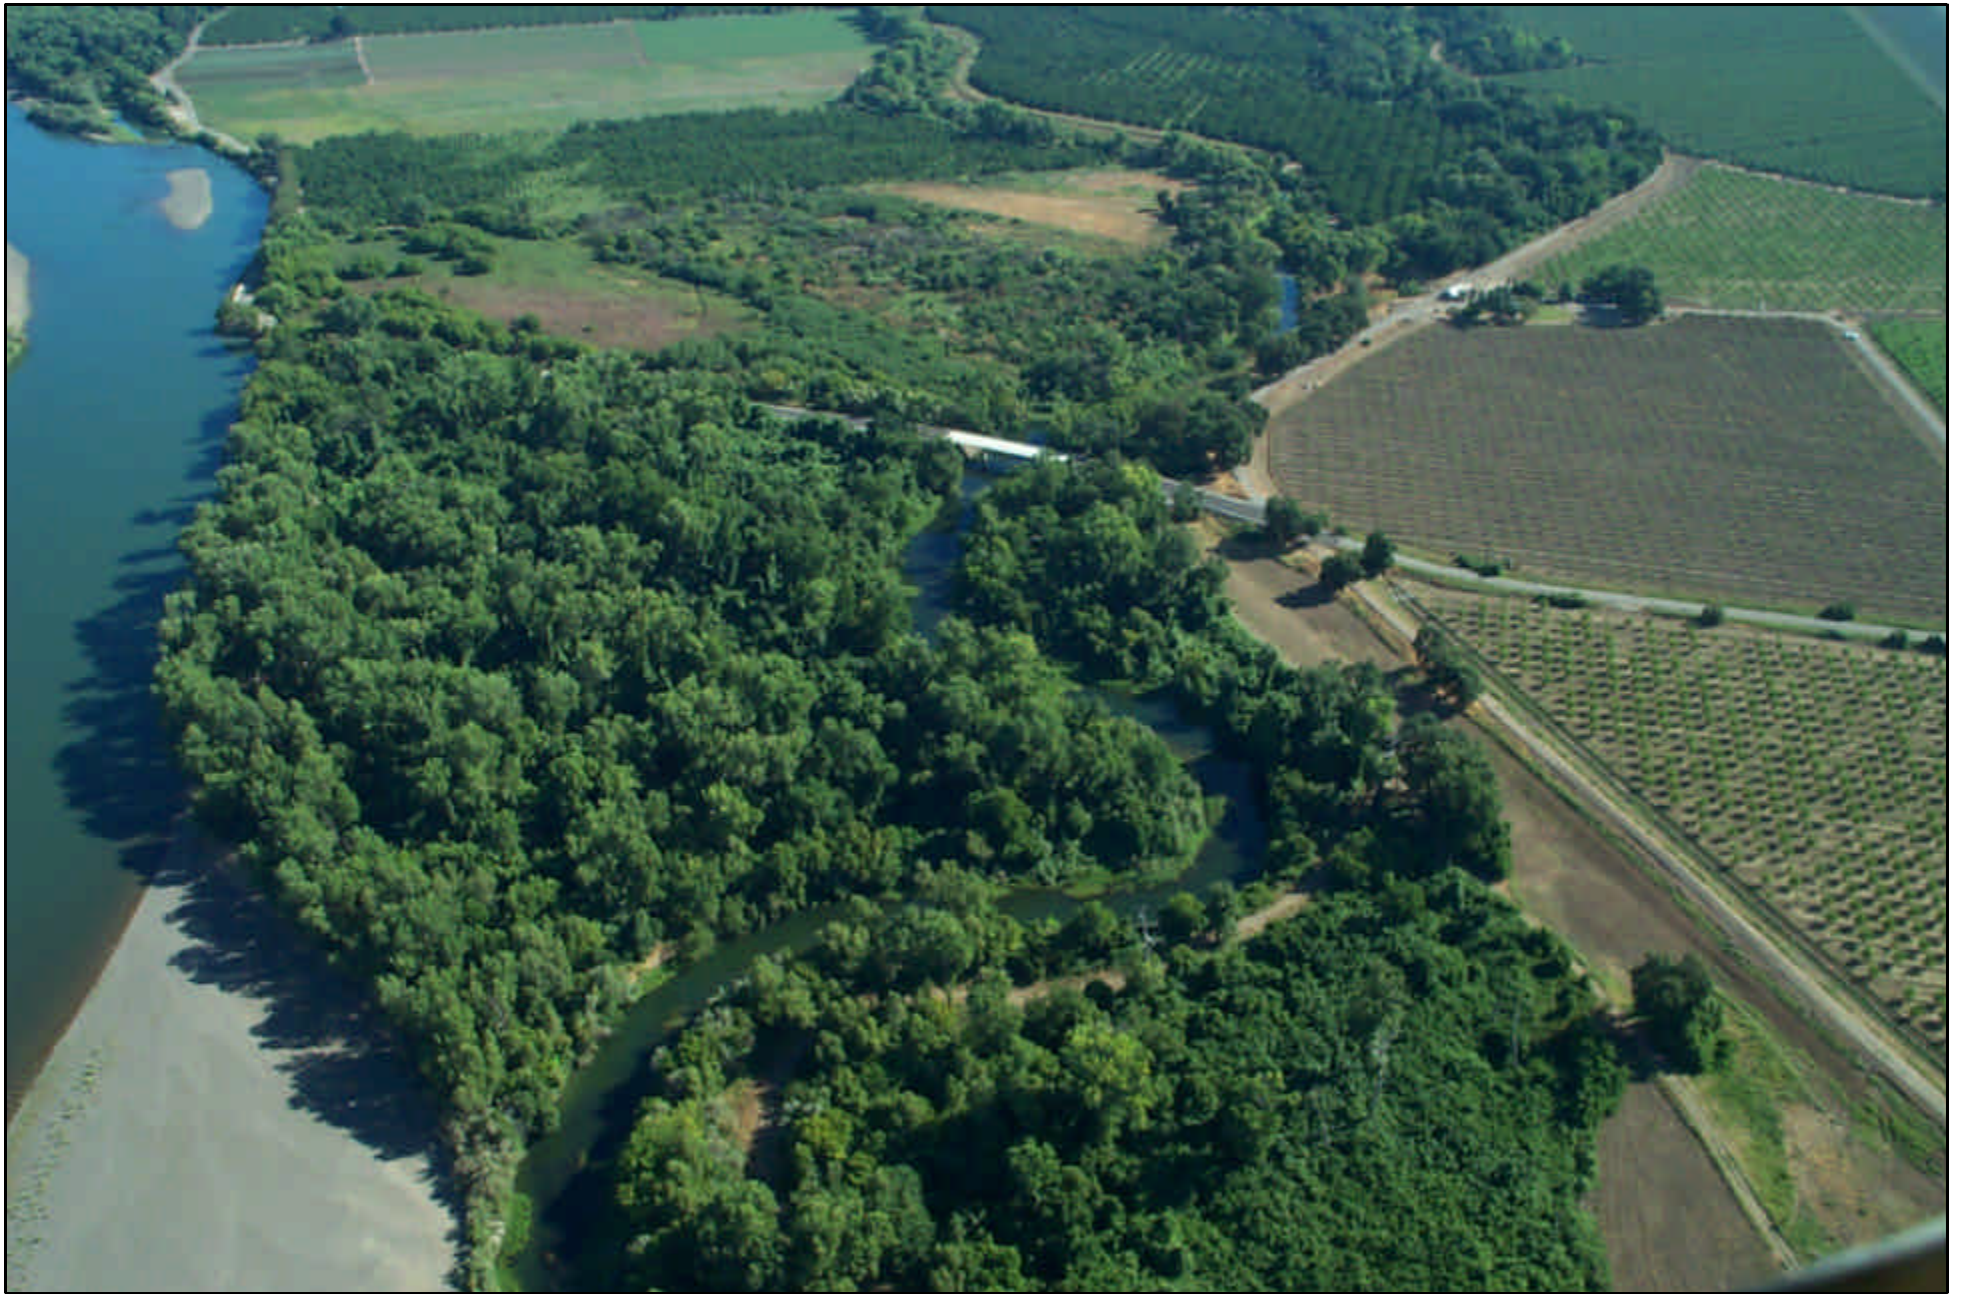
Figure 14: Well established riparian habitat along the banks of Big Chico Creek just upstream of its confluence with the Sacramento River. This physical location was, some 70 years ago, “river channel,” but subsequent to channel migration and sediment deposition by the creek and the river, this area now supports relatively mature riparian vegetation.
