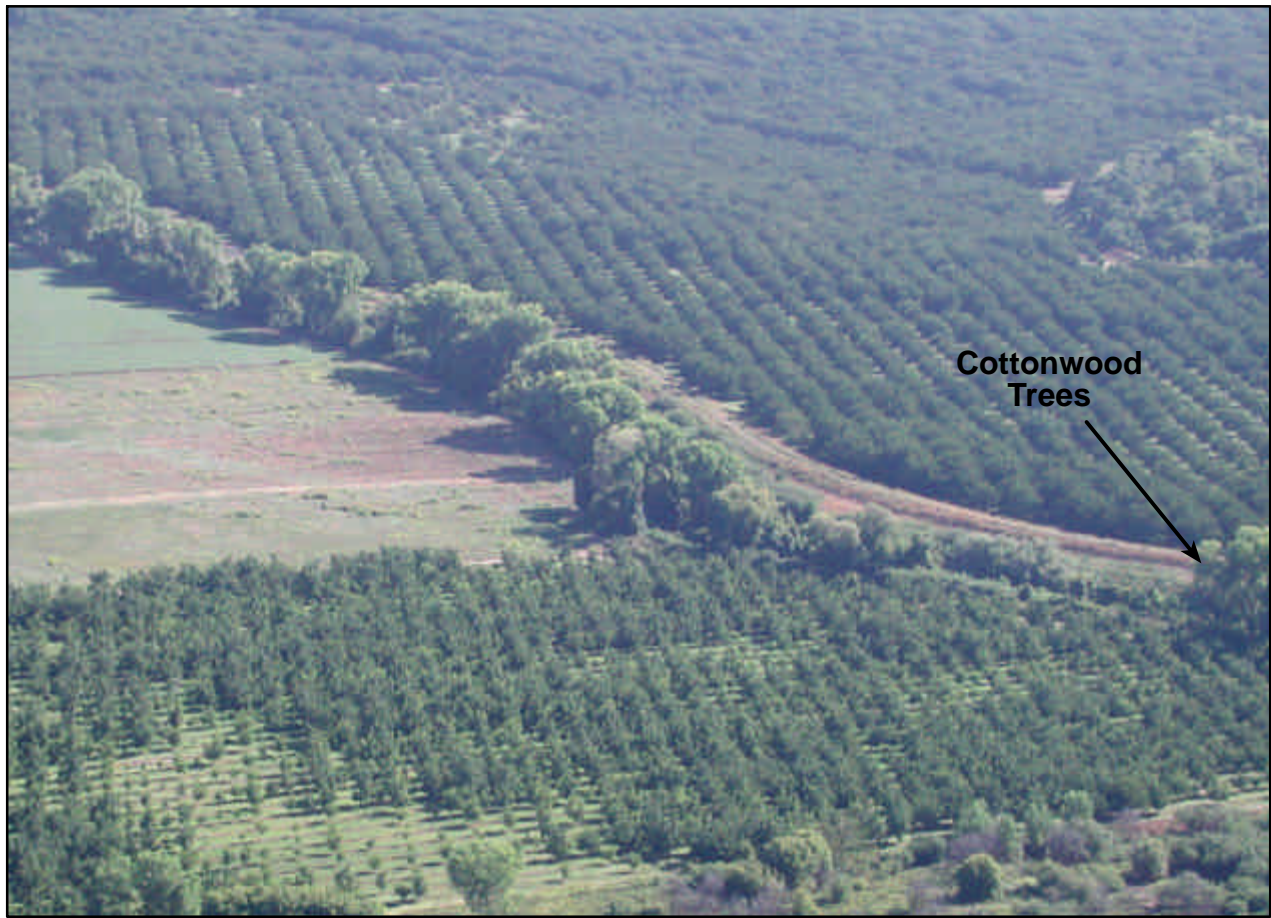
**Cottonwood
Trees**

Same Cottonwood Trees

Figure 17: Top Photograph--Oblique aerial photograph looking upstream on Mud Creek; note location of trees relative to lower photograph. Lower Photograph--Looking downstream along the right (west) bank of Mud Creek; note the location of trees from aerial photograph. Berm appears to be composed of flood debris and soils from the orchards and is covered in stall thistle in this area.
