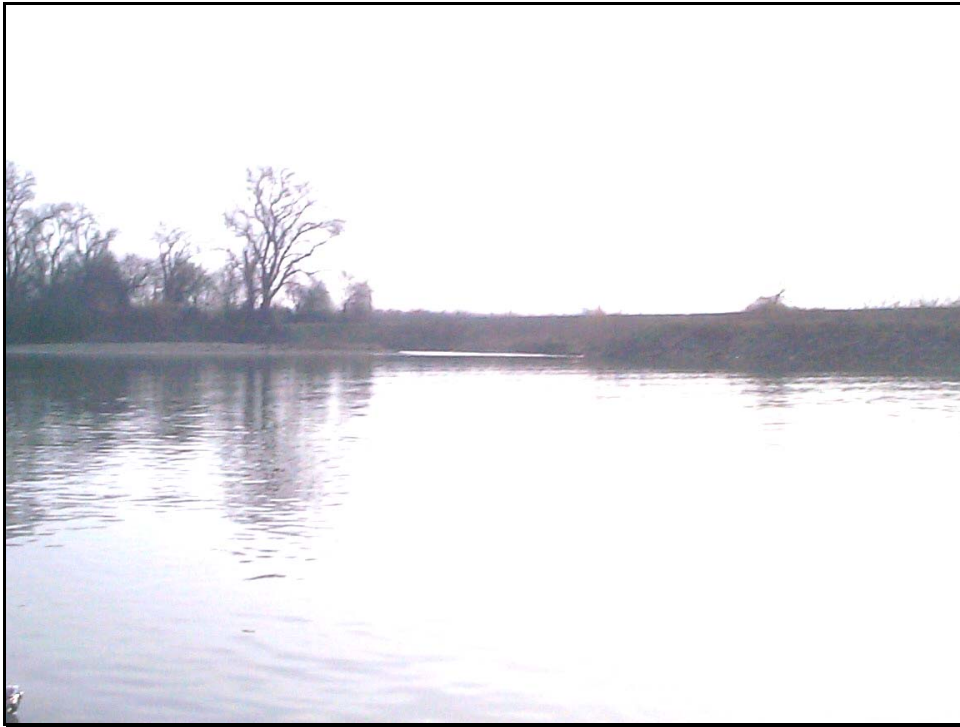
The following photographs show the areas of the river where the 1995 and the modeled cutoff are located. **Photograph 1** is looking downstream with the Road 29 levee and bank protection located on the right side of the photograph. This area is where the modeled breach would begin. **Photograph 2** is looking south from Road 29 and shows the modeled cutoff path across Kimmelshue Bend. **Photograph 3** is a view looking north across the Sacramento River at the location where the modeled cutoff would re-enter the river.

Photograph 1. Looking Downstream along the Sacramento River with the Road 29 Embankment along the Right Side (RM 188.0)
